**HISTORIC DISTRICT
REVIEW COMMISSION
Regular Meeting**

February 21, 2023

HDRC Case #23-003J (Amendment to 21-020J) Consideration of a change in material size of architectural features at 462 E Kansas, Jewell Historic District, a 353 Tax Abatement project.

HDRC Case # 23-001J Consideration of an after the fact COA for a temporary ADA ramp at 471 E Kansas, Jewell Historic District

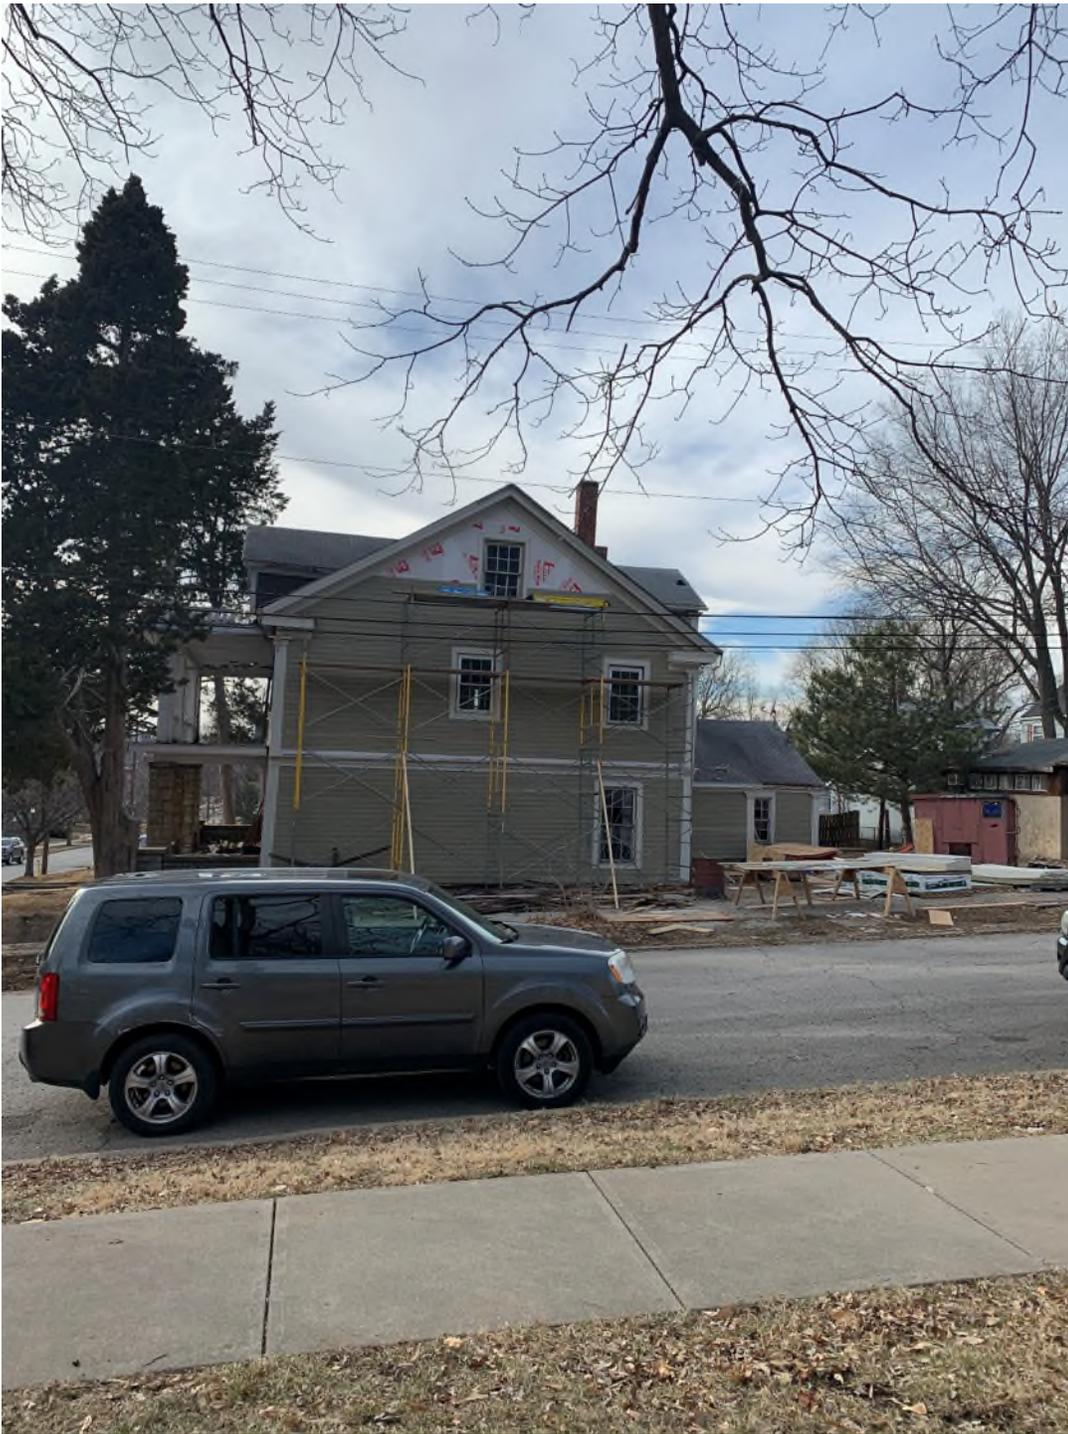
Exhibit D Existing
Conditions on 2.15.23
East Elevation
Pg 1 of 7

- Modifications were made to the size and profiles of architectural details, that do not appear to be like in kind. (see details and explanation from the applicant in Memo, Exhibit C).
 - Bed molding was changed to crown molding
 - East gable eaves- replacement does not appear to be like in kind.
 - Frieze board under gable appears to be too long, it should terminate short of end of soffit.
 - Door and window casings are too large, should match original.

With the following stipulations, staff recommends approval if the original materials are not salvageable:

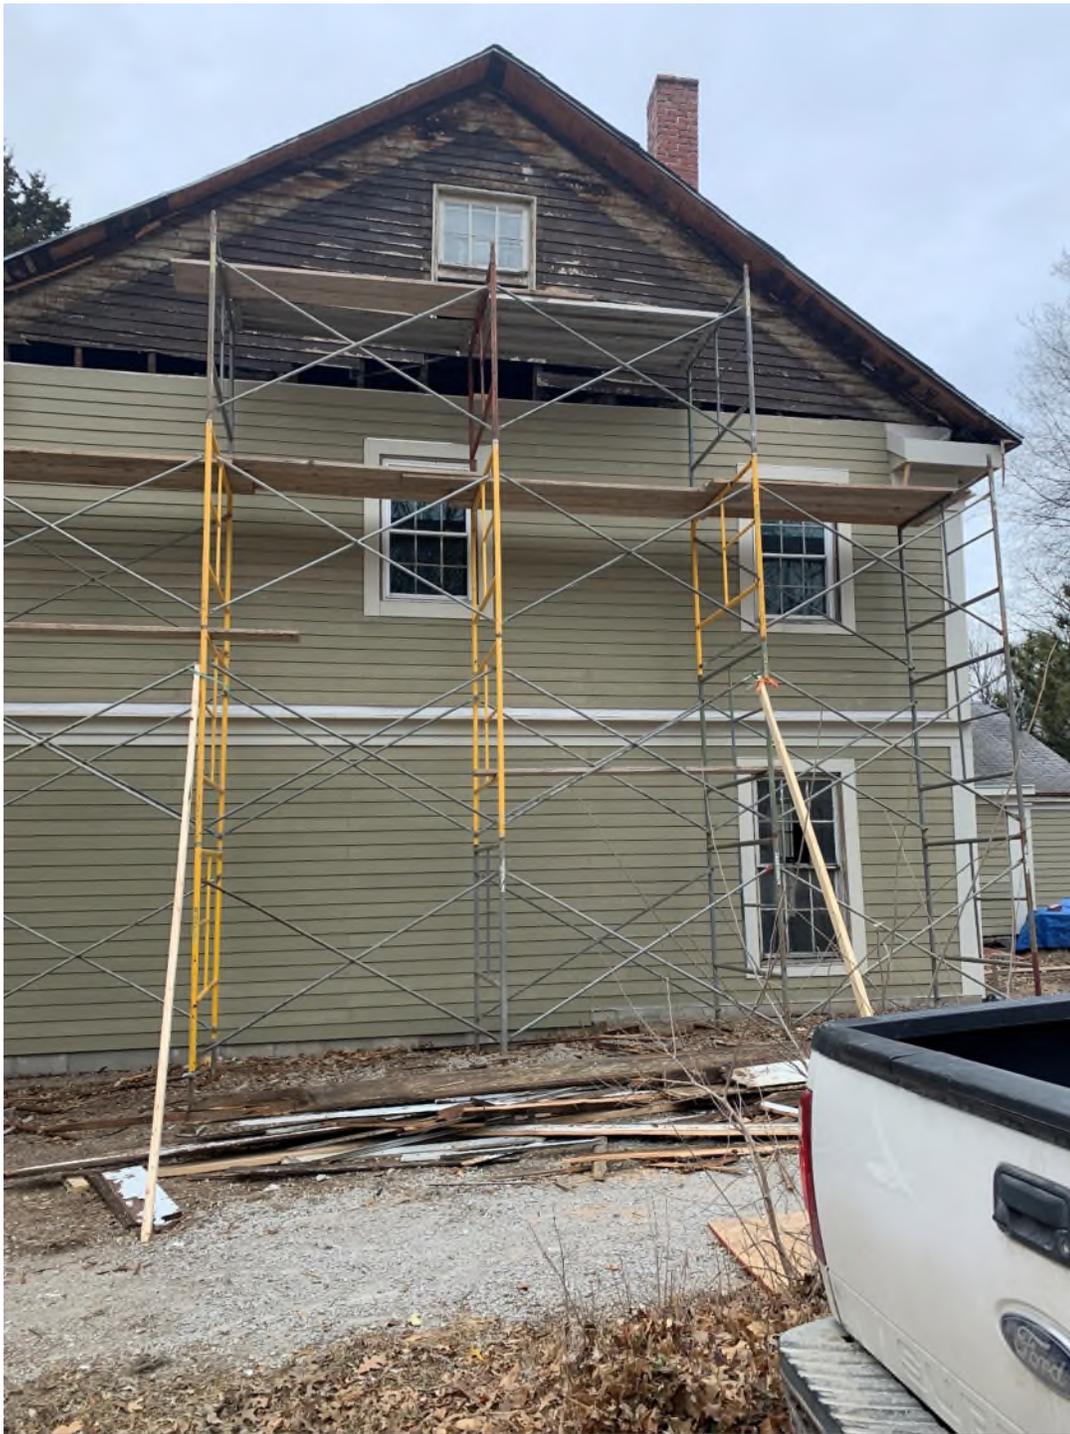
East Elevation
Page 3 of 7 Photos

- East Gable Soffit system has been removed - it was rotten and will be replaced.
- Gable returns have been changed from flat to pitched, please duplicate original - will correct.

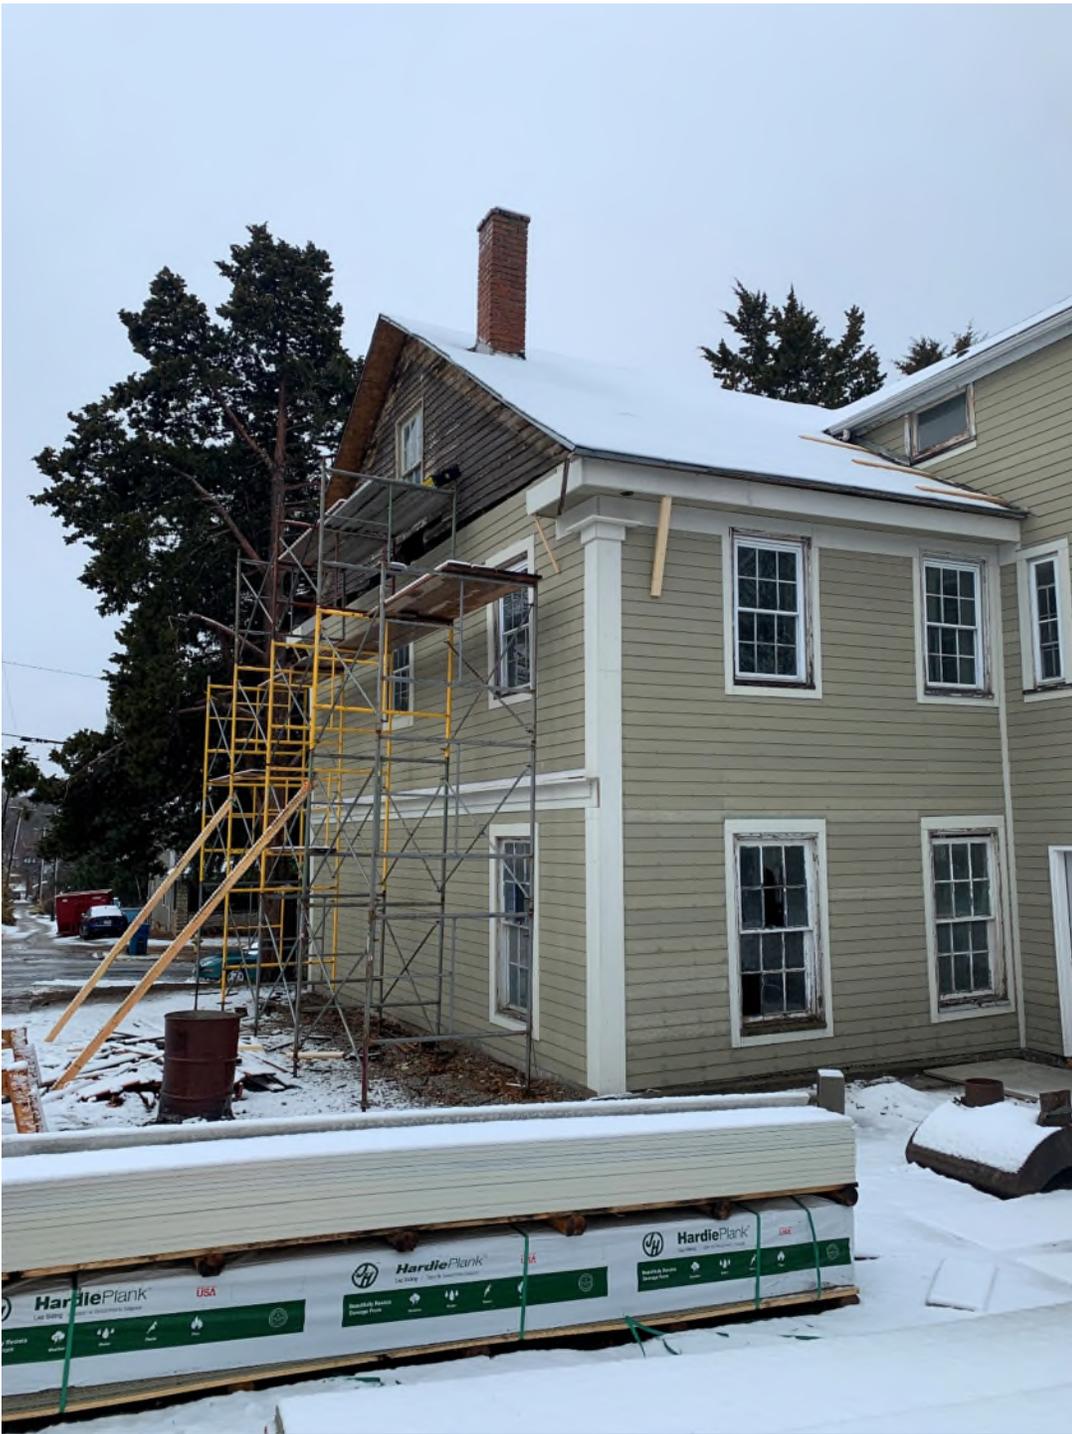
NE Elevation
Page 4 of 7 Photos

- Window Millwork- Windows are "picture" framed. Casings are larger than original. Added apron (please duplicate original)
- Outside Corner Caps- Decorative top under soffit- should have 2x flat cap not 1x
- Central frieze/banding- Appears smaller and not in the same location in relation to the window head casing as original. Secondary 1x is too wide. Missing on the north side.
- East Gable Soffit system has been removed
- Gable returns have been changed from flat to pitched, please duplicate original.

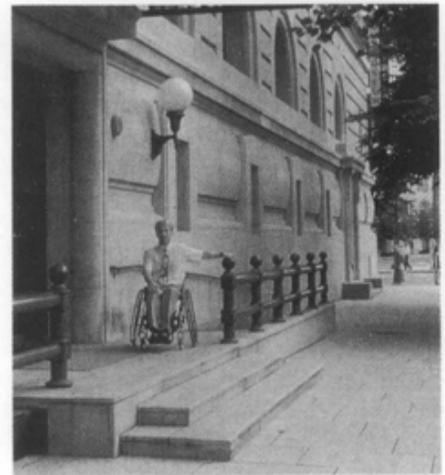
Figure 1. It is important to identify the materials, features, and spaces that should be preserved when planning accessibility modifications. These may include stairs, railings, doors, and door surrounds. Photo: National Park Service files.

decorative ornamental hardware, and narrow pathways and corridors, pose barriers to persons with disabilities, particularly to wheelchair users (See Figure 1).

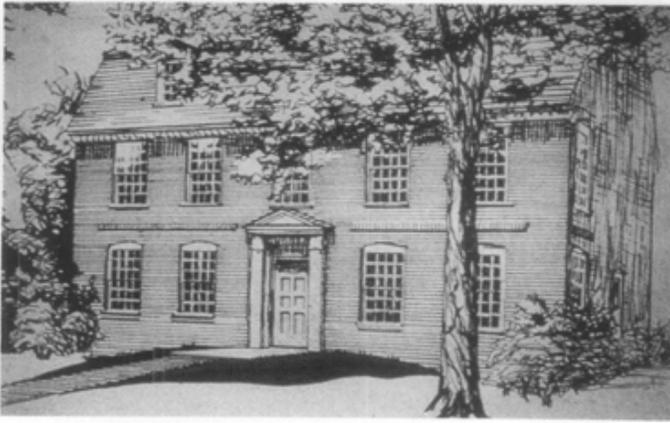
A.

Figure 3. Before implementing accessibility modifications, owners should consider the potential effect on their historic property. At the Derby House in Salem, Massachusetts, several solutions to make the entrance accessible were considered, including regrading (a); a lift (b); and a ramp (c). The solution, an entrance on a secondary elevation, preserves the building's architectural significance and is convenient to designated parking. Drawings: National Park Service Files..

Once a property's significant materials and features have been identified, and existing and required levels of accessibility have been established, solutions can be developed (See Figure 3). Solutions should provide the greatest amount of accessibility without threatening or destroying those materials and features that make a property significant. Modifications may usually be phased over time as funds are available, and interim solutions can be considered until more permanent solutions are implemented. A team comprised of persons with disabilities, accessibility and historic preservation professionals, and building inspectors should be consulted as accessibility solutions are developed.

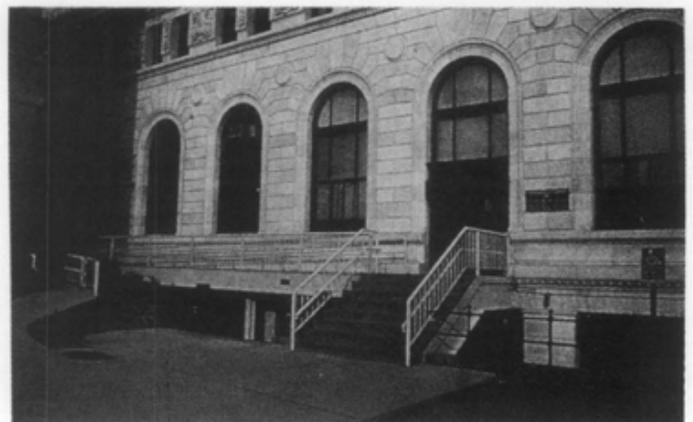
Figure 4. Parking designated for people with disabilities is provided near an accessible entrance to the Springfield Library in Springfield, Massachusetts. Photo: William Smith.

Providing Convenient Parking. If parking is provided, it should be as convenient as possible for people with disabilities. Specially designated parking can often be created to improve accessibility (See Figure 4). Modifications to parking configurations and pathways should not alter significant landscape features.

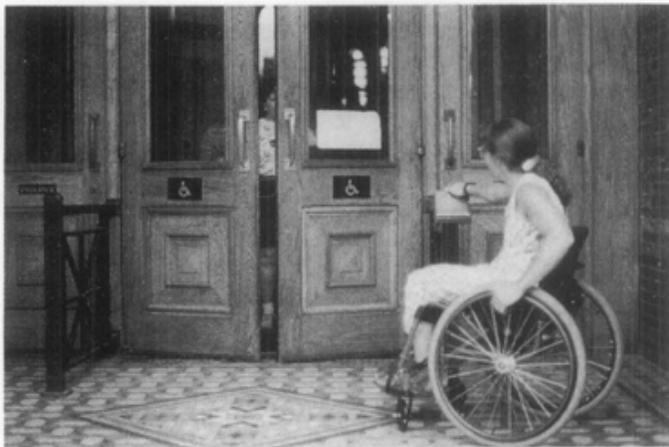
Figure 5. A universal access symbol clearly marks the Arts and Industries Building in Washington, D.C., and a push plate (right) engages the automatic door-opener. Photo: Thomas Jester.

Whenever possible, access to historic buildings should be through a primary public entrance. In historic buildings, if this cannot be achieved without permanent damage to character-defining features, at least one entrance used by the public should be made accessible. If the accessible entrance is not the primary public entrance, directional signs should direct visitors to the accessible entrance (See Figure 5). A rear or service entrance should be avoided as the only mean of entering a building.

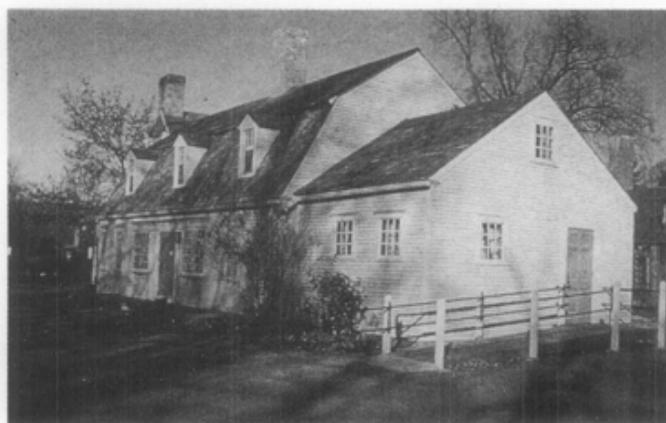
Figure 7. This ramp is convenient for visitors with disabilities and preserves the building's historic character. The design is also compatible in scale with the building. Photo: William Smith.

Incorporating Ramps. Permanent ramps are perhaps the most common means to make an entrance accessible. As a new feature, ramps should be carefully designed and appropriately located to preserve a property's historic character (See Figure 7). Ramps can often be incorporated behind

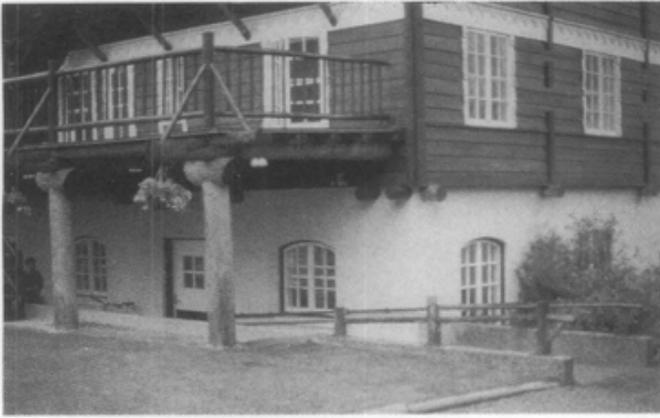
Figure 8. A new below-grade ramp provides access to Lake MacDonald Lodge in Glacier National Park. Photo: Thomas Jester

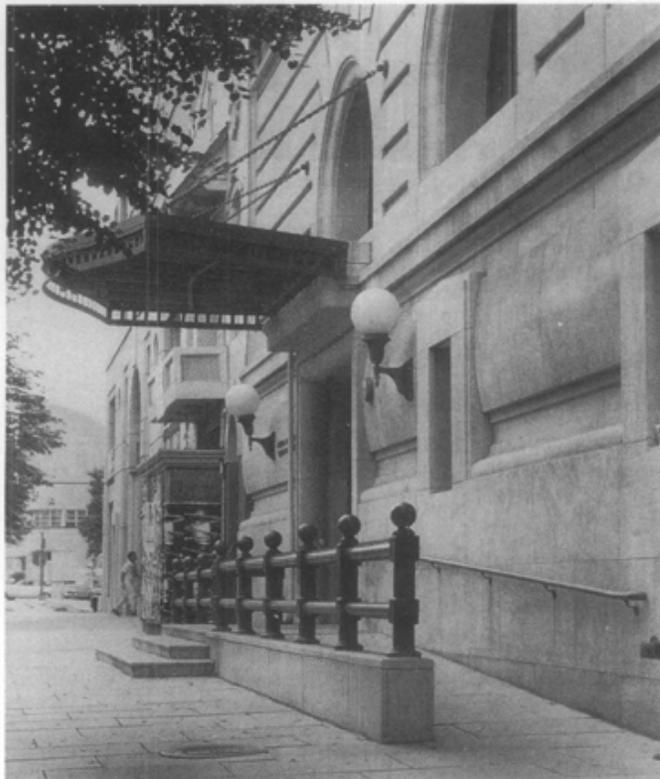
Figure 9. This ramp was created by infilling the window-well and slightly modifying the historic railing. The ramp preserves this building's historic character. Photo: Thomas Jester.

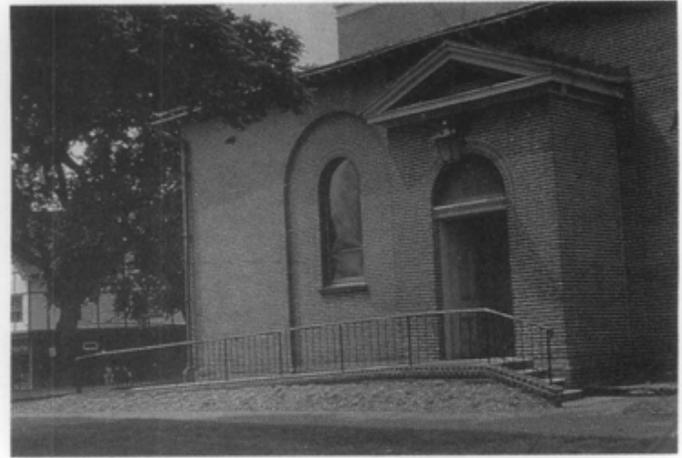
Figure 10. This brick ramp provides access to St. Anne's Episcopal Church in Annapolis, Maryland. Its design is compatible with the historic building. Photo: Charity V. Davidson.

Ramps can be faced with a variety of materials, including wood, brick, and stone. Often the type and quality of the materials determines how compatible a ramp design will be with a historic property (See Figure 10). Unpainted pressure-treated wood should not be used to construct ramps because it usually appears temporary and is not visually compatible with most historic properties. Railings

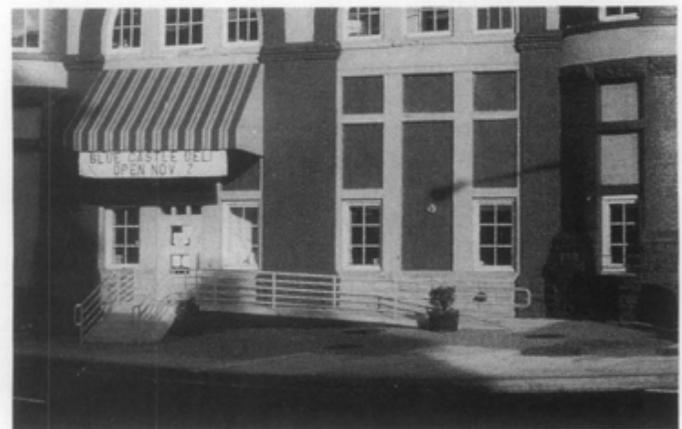
Figure 11. Simple, contemporary railings that extend beyond the ramp slope make this ramp compatible with the industrial character of this building. Photo: Thomas Jester.

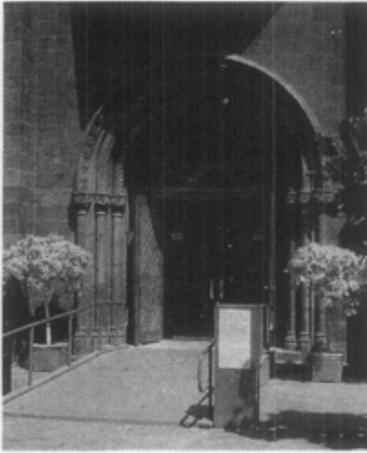
Figure 12. The Smithsonian Institution installed a temporary ramp on its visitor's center to allow adequate time to design an appropriate permanent ramp. Photo: Thomas Jester.

Temporary or portable ramps are usually constructed of light-weight materials and, thus, are rarely safe or visually compatible with historic properties. Moreover, portable ramps are often stored until needed and, therefore, do not meet accessibility requirements for independent access. Temporary and portable ramps, however, may be an acceptable interim solution to improve accessibility until a permanent solution can be implemented (See Figure 12).

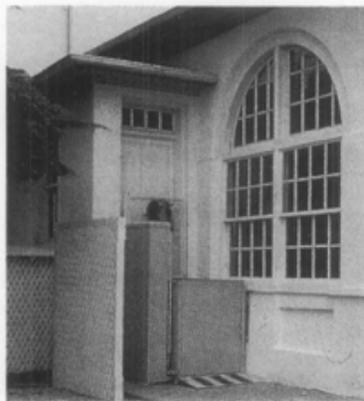
Figure 13. Platform lifts like the one used on this building require minimal space and can be removed without damaging historic materials. Shielded with lattice work, this lift is also protected by the roof eaves. Approach path should be stable, firm, and slip resistant. Photo: Sharon Park.

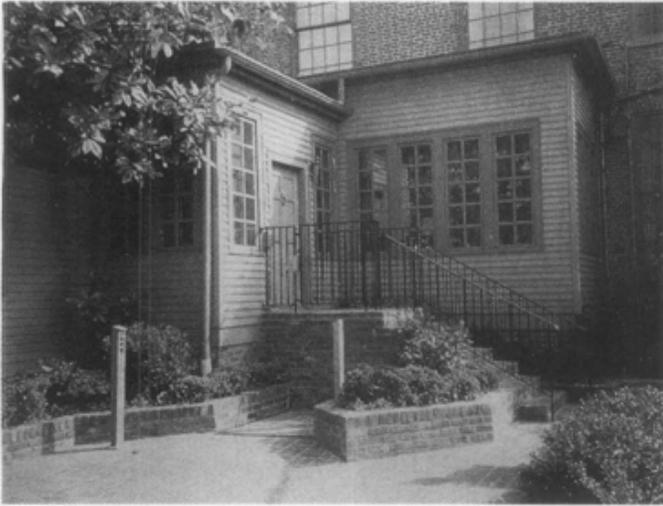
Figure 14. At the Lieutenant Governor's Mansion in Frankfort, Kentucky, a retracting lift (b) was installed to minimize the visual effect on this historic building when not in use (a). Photos: Aging Technology Incorporated.

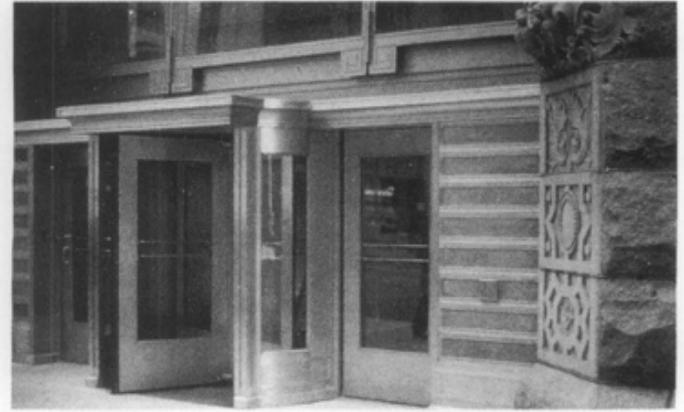
Figure 16. During the rehabilitation of the Rookery in Chicago, the original entrance was modified to create an accessible entrance. Two revolving doors were replaced with a new one flanked by new doors, one of which is operated with a push-plate door opener. Photo: Thomas Jester.

(operated by push buttons, mats, or electronic eyes) and power-assisted door openers can eliminate or reduce door pressures that are accessibility barriers, and make single or double-leaf doors fully operational (See Figure 16).

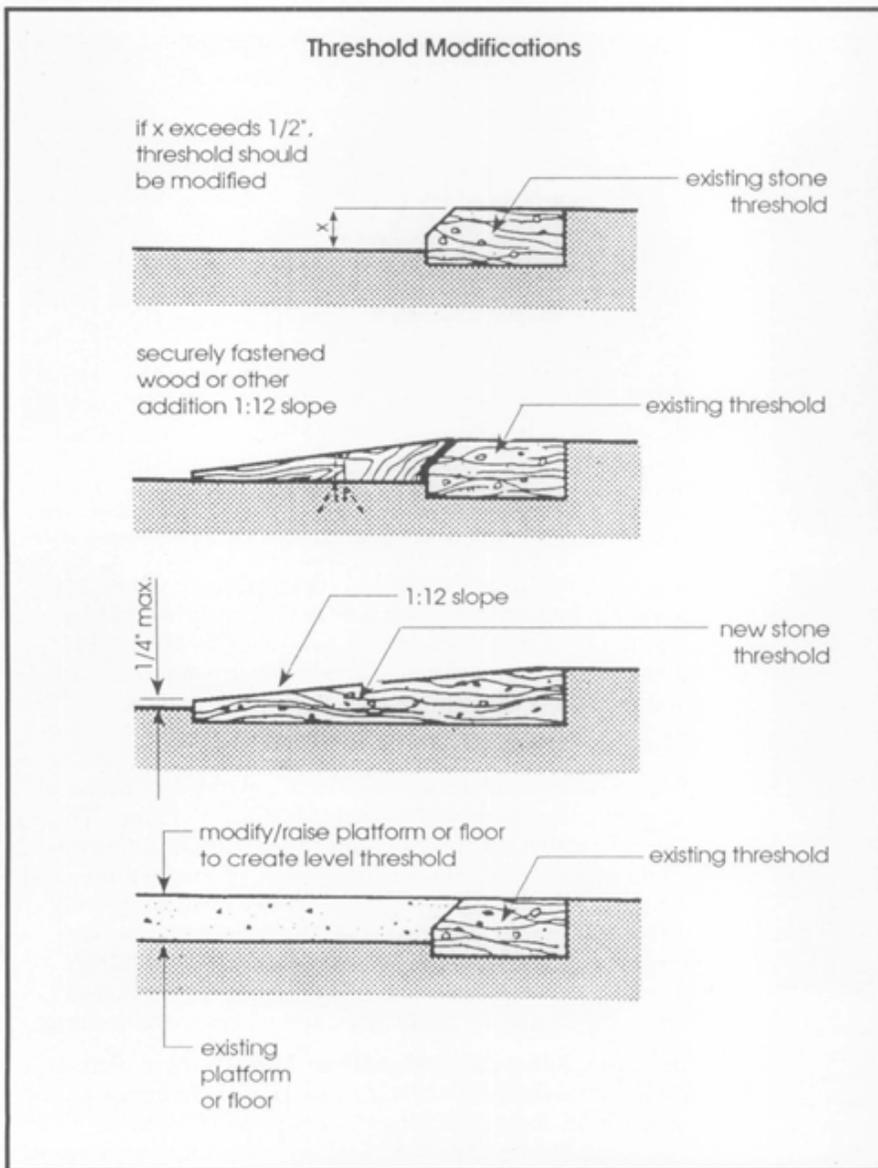
Figure 17. Thresholds that exceed allowable heights can be modified several ways to increase accessibility. Source: Uniform Federal Accessibility Standard (UFAS) Retrofit Manual.

requirements. If the threshold is deemed to be significant, a bevel can be added on each side to reduce its height (See Figure 17). Another solution is to replace the threshold with one that meets applicable accessibility requirements and is visually compatible with the historic entrance.

Altering Door Thresholds. A door threshold that exceeds the allowable height, generally 1/2" (1.3 cm), can be altered or removed with one that meets applicable accessibility

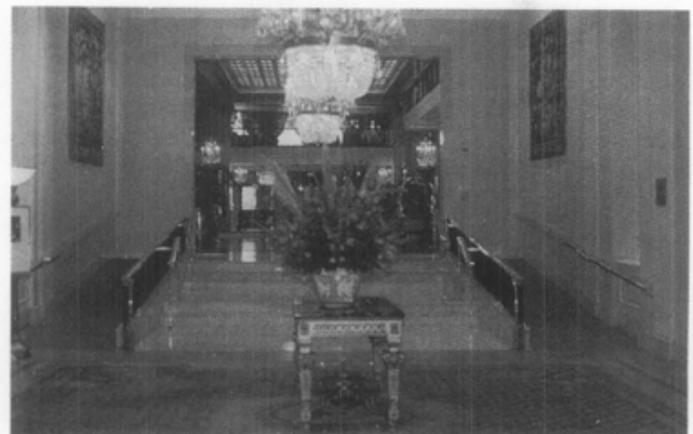
Figure 18. Symmetrical ramps at the Mayflower Hotel in Washington, D.C., provide access to the hotel's lower level. The design for the ramps respects the historic character of this landmark building. Photo: Thomas Jester.

Installing Ramps and Wheelchair Lifts. If space permits, ramps and wheelchair lifts can also be used to increase accessibility inside buildings (See Figures 18 & 19). However, some States and localities restrict interior uses of wheelchair lifts for life-safety reasons. Care should be taken to install these new features where they can be readily accessed. Ramps and wheelchair lifts are described in detail on pages 4-6.

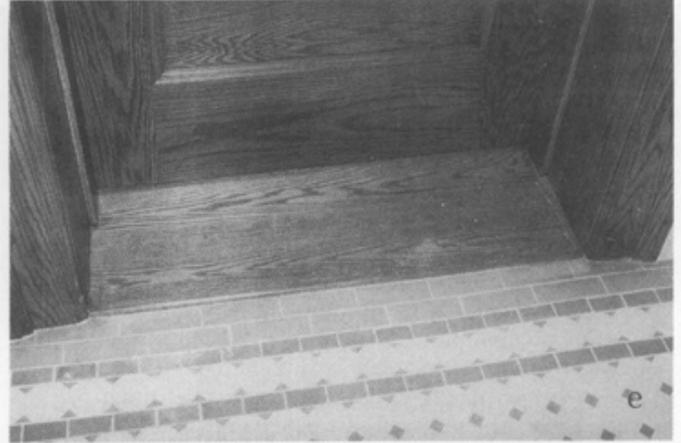
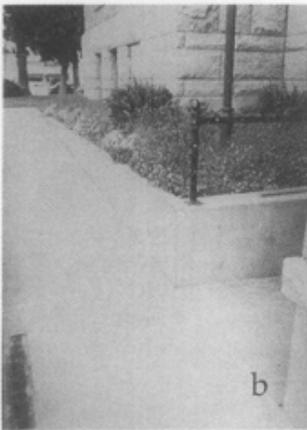
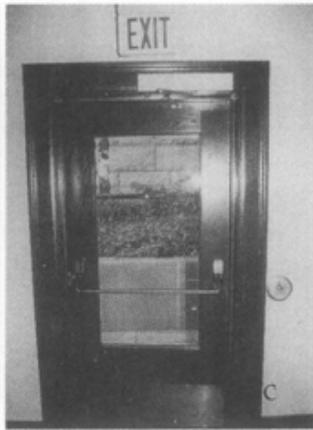
MAKING A HISTORIC BUILDING ACCESSIBLE

The Orange County Courthouse (a), located in Santa Ana, California, was rehabilitated in the late 1980s as a county museum. As part of the rehabilitation, the architect sensitively integrated numerous modifications to increase accessibility. To preserve the building's primary elevation, a new public entrance was created on the rear elevation where parking spaces are located. A ramp (b) leads to the accessible entrance that can be opened with a push-plate automatic door-opener (c). Modifications to interior features also increased accessibility. To create an accessible path of travel, offset hinges (d) were installed on doors that were narrower than 32 inches (81.3 cm). Other doors were rethreaded to reduce the door pressure. Beveling the 1" high thresholds (e) reduced their height to approximately 1/4 inch (.64 cm). The project architect also converted a storeroom into an accessible restroom (f). The original stairway, which has open grillwork, was made more accessible by applying slip-resistant pressure tape to the marble steps (g). And the original elevator was upgraded with raised markings, alarm lights, and voice floor indicators. Photos: Milford Wayne Donaldson, FAIA.

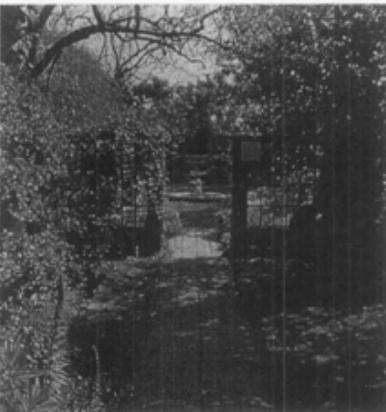
(b.) The Friendly Garden at Ranchos Los Alamitos, a historic estate with designed gardens in southern California, was made accessible with limited widening of its existing approach path. Photo: Ranchos Los Alamitos Foundation.

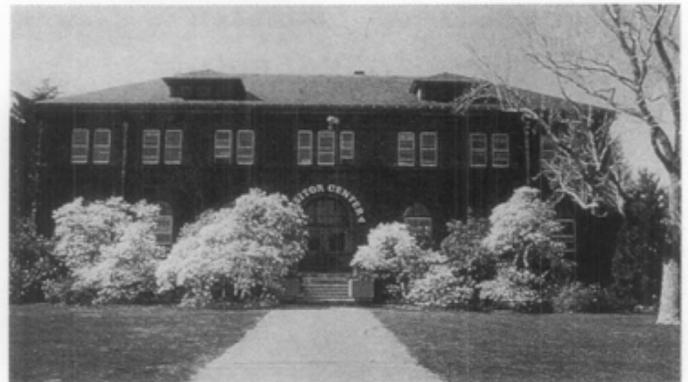
(c.) Hunnewell Visitor's Center before rehabilitation, revealing the altered landscapes. Photo: Jennifer Jones, Carol R. Johnson and associates.

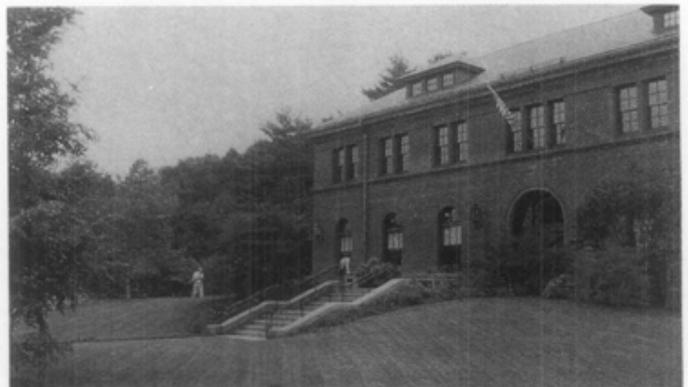
(d.) Hunnewell Visitors Center's entrance following rehabilitation, integrating an accessible path (left), platform, and new steps. Photo: Charles Birnbaum.

allowing the visitor to enjoy its architectural detail. A new walk winds up the gentle earthen berm and is vegetated with plantings that enhance the interpretive experience from the point of orientation (d). The new curvilinear walks also provide a connection to the larger arboretum landscape for everyone.

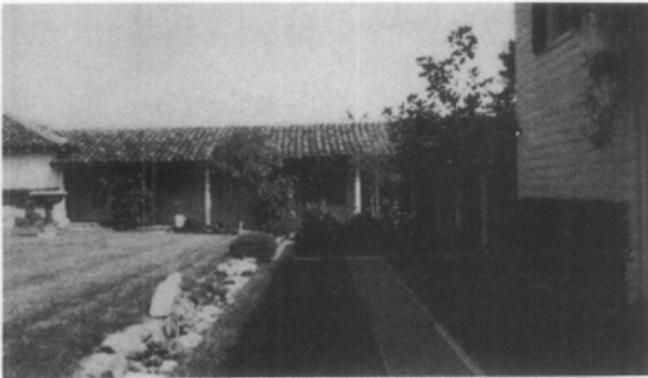
(e.) This view shows the new reinforced turf path at the Eugene O'Neill National Historic Site that preserved the narrow Historic Path. Photo: Patricia M. O'Donnell.

2. The Eugene O'Neill National Historic Site overlooks the San Ramon Valley, twenty-seven miles east of San Francisco, California. The thirteen-acre site includes a walled courtyard garden on the southeast side of the Tao House, which served as the O'Neill residence from 1937-44 (e). Within this courtyard are character-defining walks that are too narrow by today's accessibility standards, yet are a character-defining element of the historic design. To preserve the garden's integrity, the scale and the characteristics of the original circulation were maintained by creating a wheelchair route which, in part, utilizes reinforced turf. This route allows visitors with disabilities to experience the main courtyard as well.

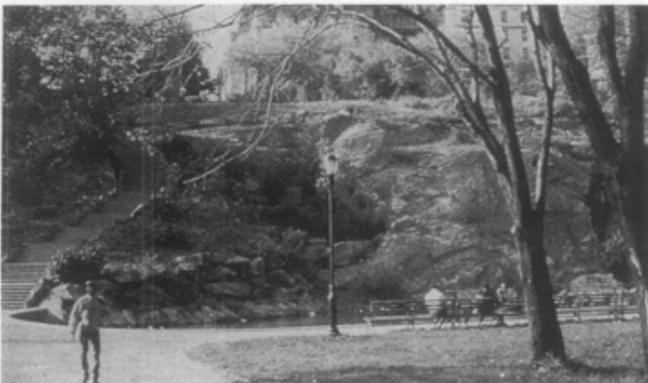
(f.) Steep terrain at Morningside Park in New York City cannot be made accessible without threatening or destroying this landscape's integrity. Photo: Quennell Rothschild Associates.

3. Morningside Park in New York City, New York, designed by Frederick Olmstead, Sr., and Calvert Vaux in 1879, is sited on generally steep, rocky terrain (f). Respecting these dramatic grade changes, which are only accessible by extensive flights of stone stairs, physical access cannot be provided without destroying the park's integrity. In order to provide some accessibility, scenic overlooks were created that provide broad visual access to the park.

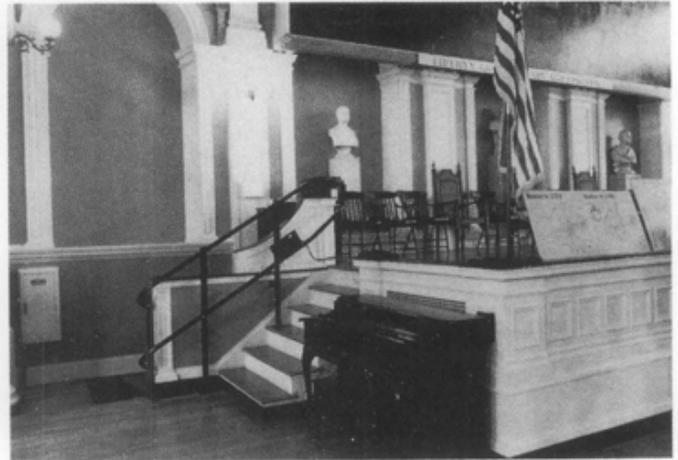
Figure 19. Inclined lifts can sometimes overcome interior changes of elevation where space is limited. This lift in Boston's Faneuil Hall created access to the floor and stage level of the State Room. Photo: Paul Holtz.

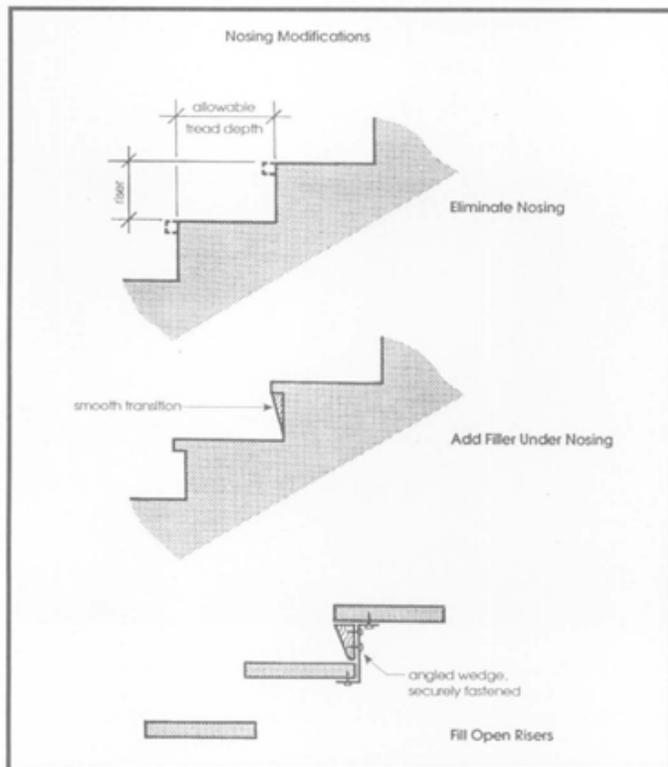
Figure 20. In certain situations it may be appropriate to modify stair nosings for persons with mobility impairments. Whenever possible, stairs should be modified by adding new materials rather than removing historic materials. Source: UFAS Retrofit Manual.

Modifying Interior Stairs. Stairs are the primary barriers for many people with disabilities. However, there are some ways to modify stairs to assist people who are able to navigate them. It may be appropriate to add hand railings if none exist. Railings should be 1 1/4" (3.8 cm) in diameter and return to the wall so straps and bags do not catch. Color-contrasting, slip-resistant strips will help people with visual impairments. Finally, beveled or closed risers are recommended unless the stairs are highly significant, because open risers catch feet (See Figure 20).

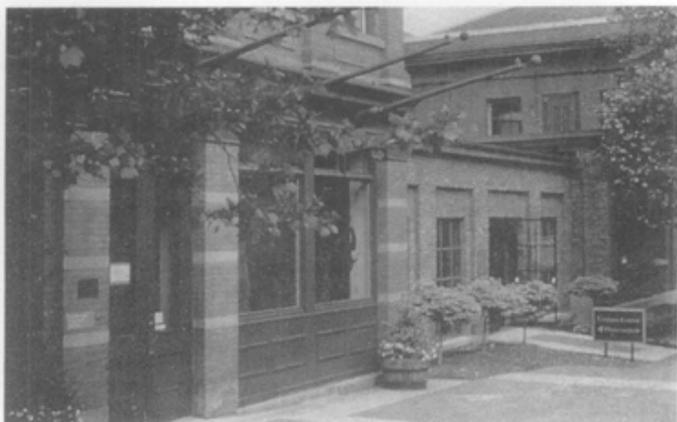
Figure 23. New additions to historic buildings can be designed to increase accessibility. A new addition links two adjacent buildings used for the Albany, New York, Visitor's Center, and incorporates an accessible entrance, restrooms, and signage. Photo: Clare Adams.
